# **A Brief Report on Pen y Bryn and Aber, Gwynedd**

**by Paul Martin Remfry**

2012

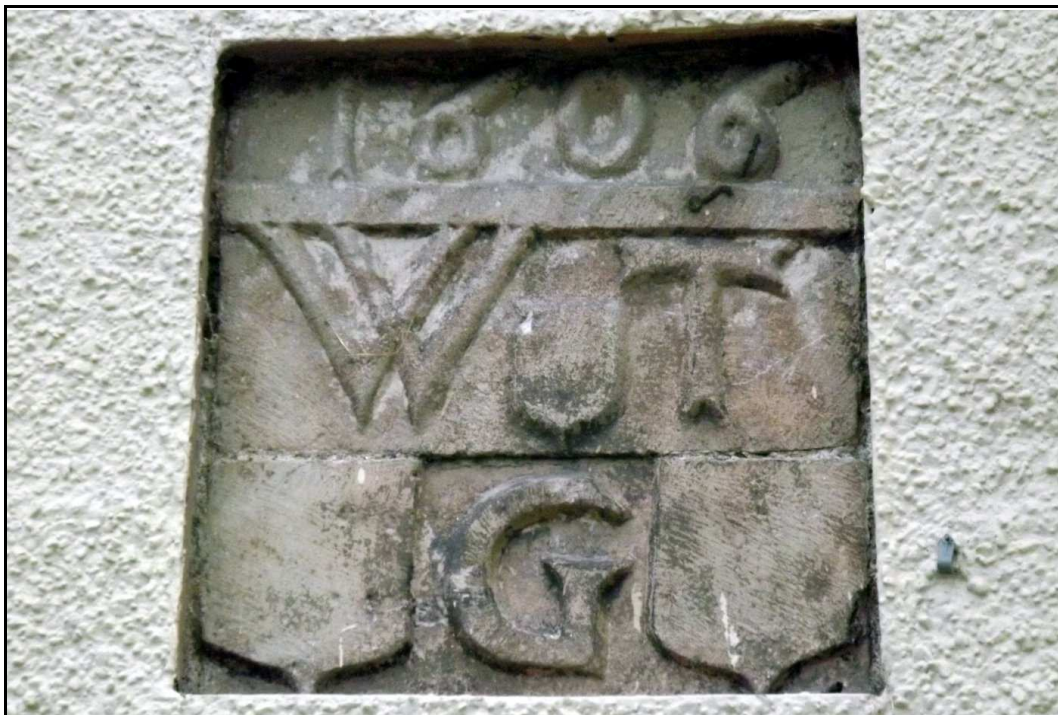
**Figure 87**, The tablet on the southern wall of Coed Helen.

Coed Helen is thought to be an early seventeenth century house judging from the tablet inscribed 1606 'W T & G' set in the eastern gable (Fig.87). This undoubtedly stands for William Thomas (1572-1634) and Gaynor Griffiths (bef.1585-1634+). William was the son of the William Thomas who died at Zutphen in 1586. Coed Helen was largely remodelled in the nineteenth century and again much altered in the mid twentieth century.

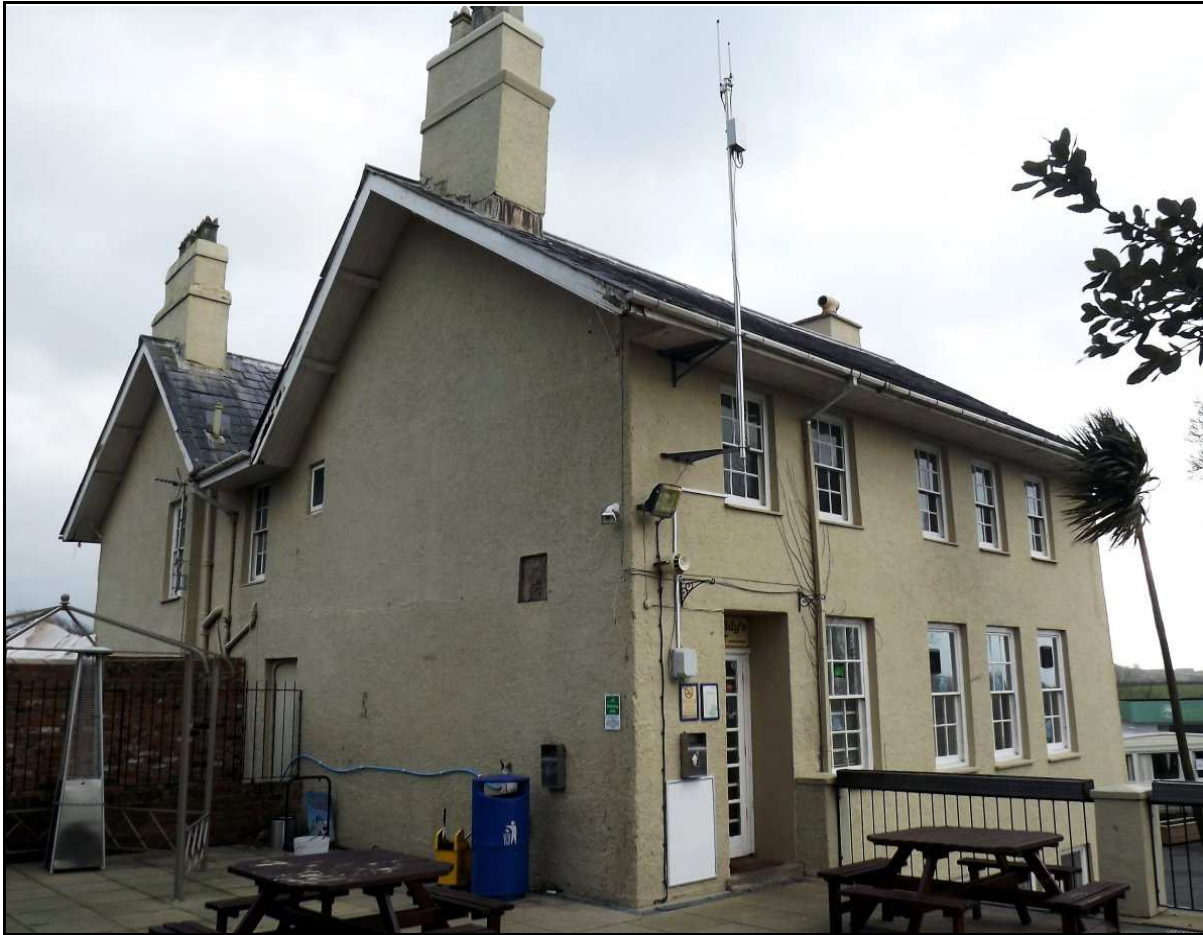
**Figure 88**, Coed Helen from the south showing the twin gabled blocks of the probably original build. The ground floor is currently buried under the patio in the foreground on this front.

It has been described as being made up of three parallel three storey gabled blocks. These were aligned north-east to south-west and were joined by short wings. This made a shape somewhat resembling a mirrored E-shaped plan. The OS map of 1888 appears to show lesser service wings on the southern side. There were walled gardens to the north-east of the house and a drive or lane wound round the small hill to the east to Caernarfon and the ferry<sup>\*42</sup>. However it appears more to me as if the original house consisted of two parallel gables as seen in the photograph (Fig.88)

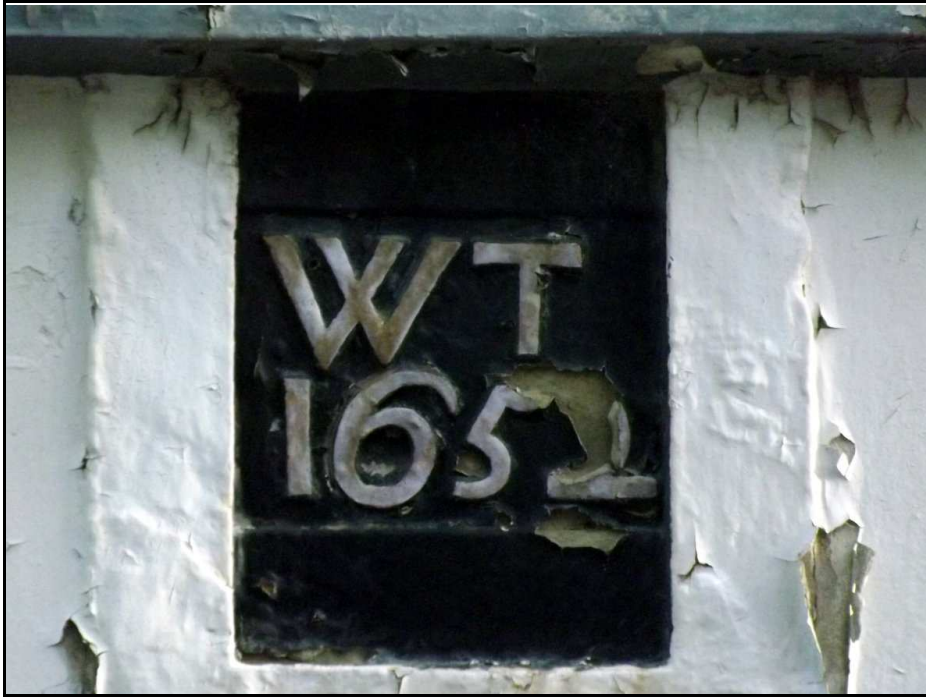
**Figure 89**, The tablet set in the wall on 2 Church Street, Caernarfon, the home of William Thomas until his death in 1652.

With the royalist defeat in the Civil Wars of the 1640's the Thomas family were very hard hit, leaving William Thomas (bef.1601-54) virtually bankrupted. As a result of having his estates sequestrated and the protracted negotiations that followed, he seems to have built himself, or refurbished, a town house in Caernarfon in 1652. The tablet commemorating this building is to be seen above 2 Church Street (Fig.89). The building that this is set in also has another tablet set in it with the monogram RN (Richard Nanney?) and the date 1808.

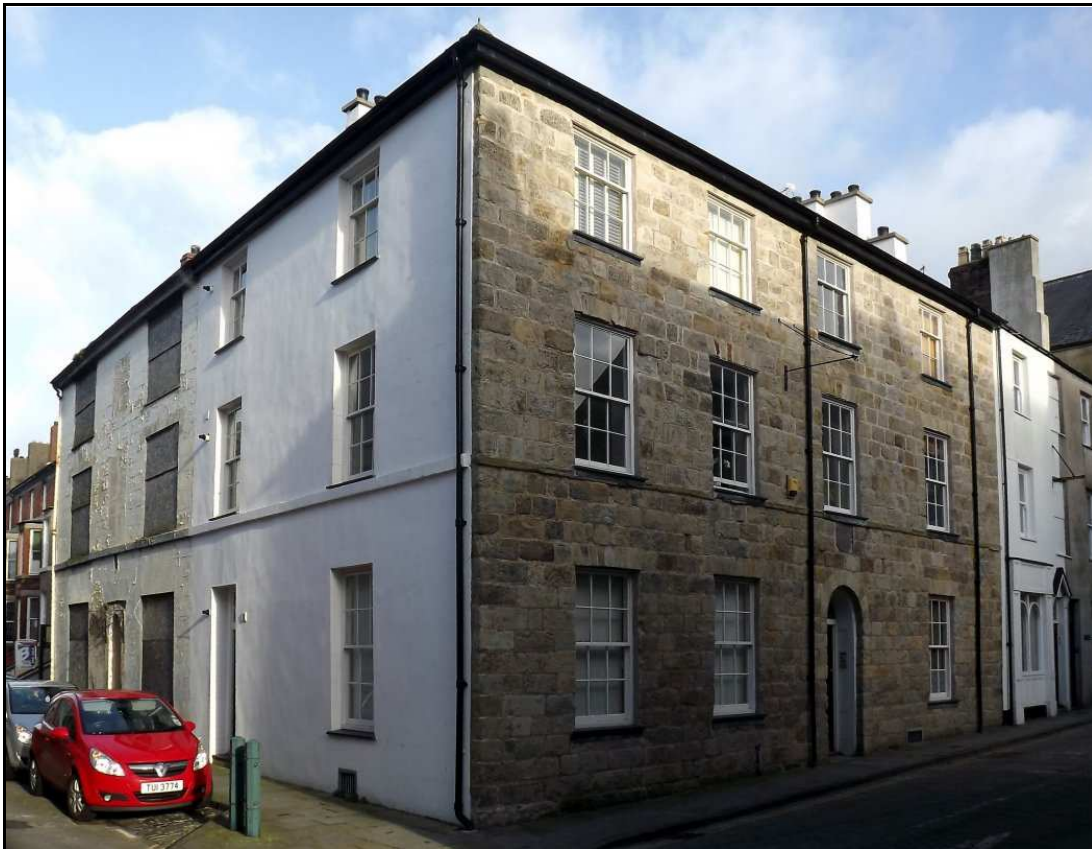
**Figure 90**, 2 Church Street, Caernarfon, boarded up to the left, is merely a part of the much bigger house. The tablet is just visible above the doorway.

The house, of which No. 2 Church Street is a part, is currently reckoned to be a late Georgian town house built of coursed and squared stone (Fig.90). It is three storeys high and has in places been heavily damaged by fire in the 1990's which has yet to be repaired. As the house is stone built it could truly be nineteenth century if the fenestration is to be believed. However the fact that twin tablets are attached to the building of such widely different dates should allow for a great deal of caution here. Certainly the entire building as it stands now how much more in common with Coed Helen than either do with Pen y Bryn. If the tablets built into both structures are to be believed 2 Church Street and Coed Helen might well have been built by father (d.1634) and son (d.1654).
